Advisory Region Bridger Range Longitude -110.93W Latitude 45.83N

Forecast link: <u>GNFAC Avalanche Advisory for Sun Feb 22, 2015GNFAC Avalanche Forecast for Sat Feb 21,</u> <u>2015</u> Bridger Range, 2015-02-21

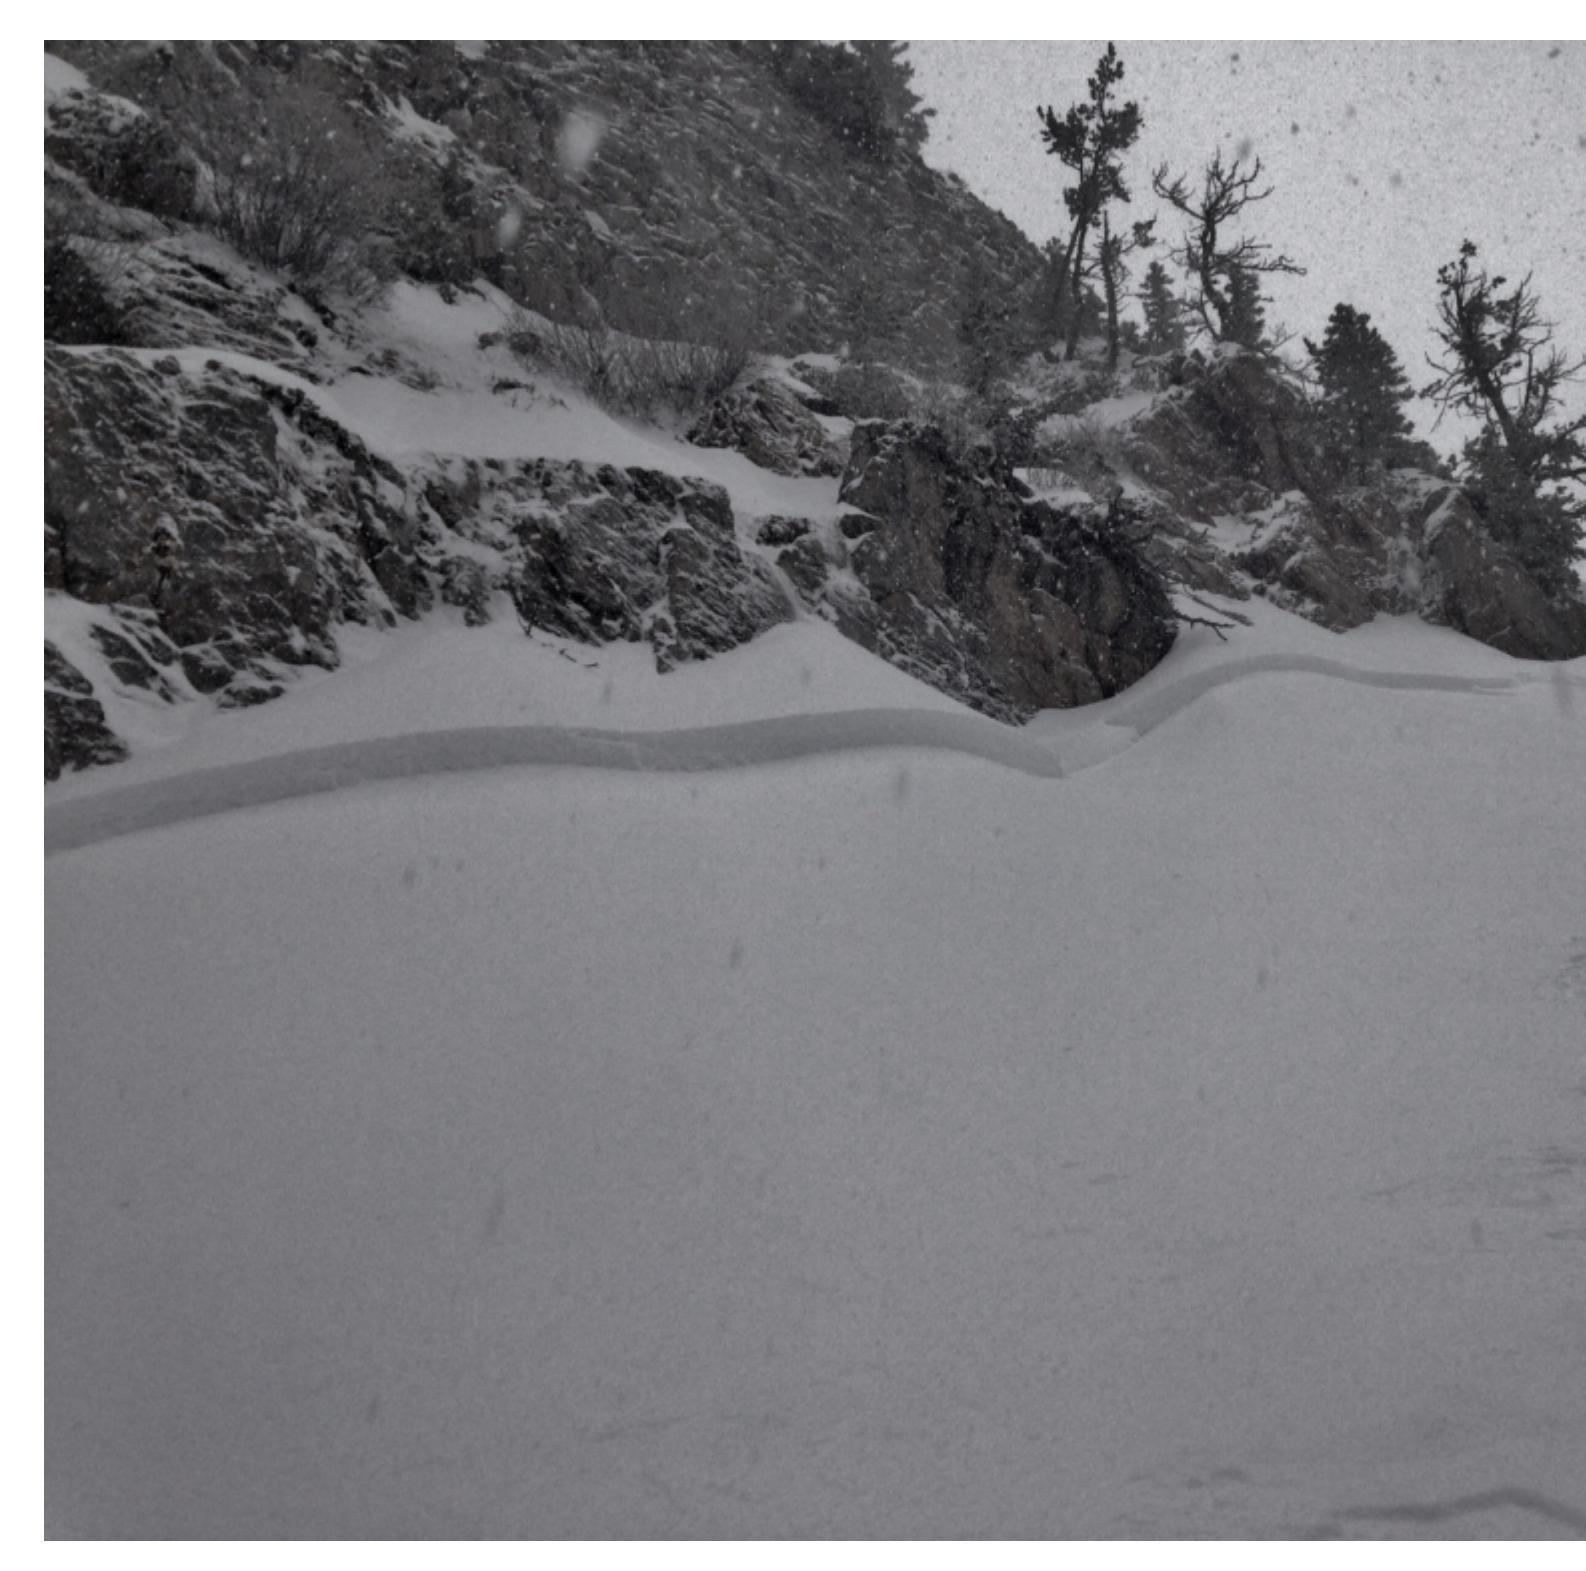
"Triggered two small avalanches in wolverine bowl today. One started from sluff we kicked off while descending from the ramp into the bowl. The second was triggered by my friend on a 40 degree SE convex slope. The crown was no deeper then 1 ft, but it broke over 150ft wide. Not enough debris to be scary, but with another foot of snowfall I would worry. Both slides broke on a soft crust at the new/old interface." Photo: P. Dixon
